**R. Warren Krager, R.G., C.E.G.
Consulting Engineering Geologist
Oregon CEG #E957
Washington LEG #314**

May 13, 2020

**Subject: Engineering Geologic Hazard Report
 Proposed Deck Extension
 79209 Ray Brown Road
 Clatsop County Tax Lot 41031CBC1102
 Cove Beach, Oregon**

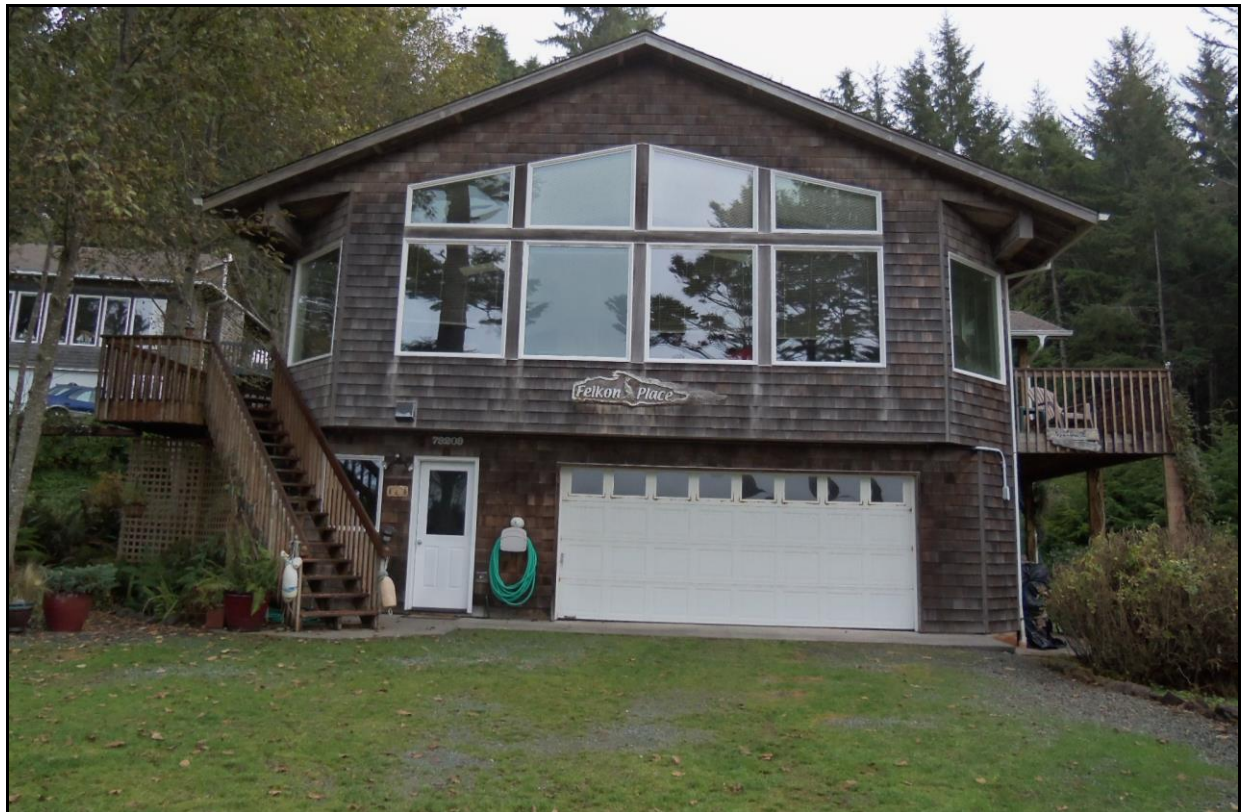
Photo 1- West side of existing home where proposed deck addition is planned, Photo courtesy of Clatsop County.

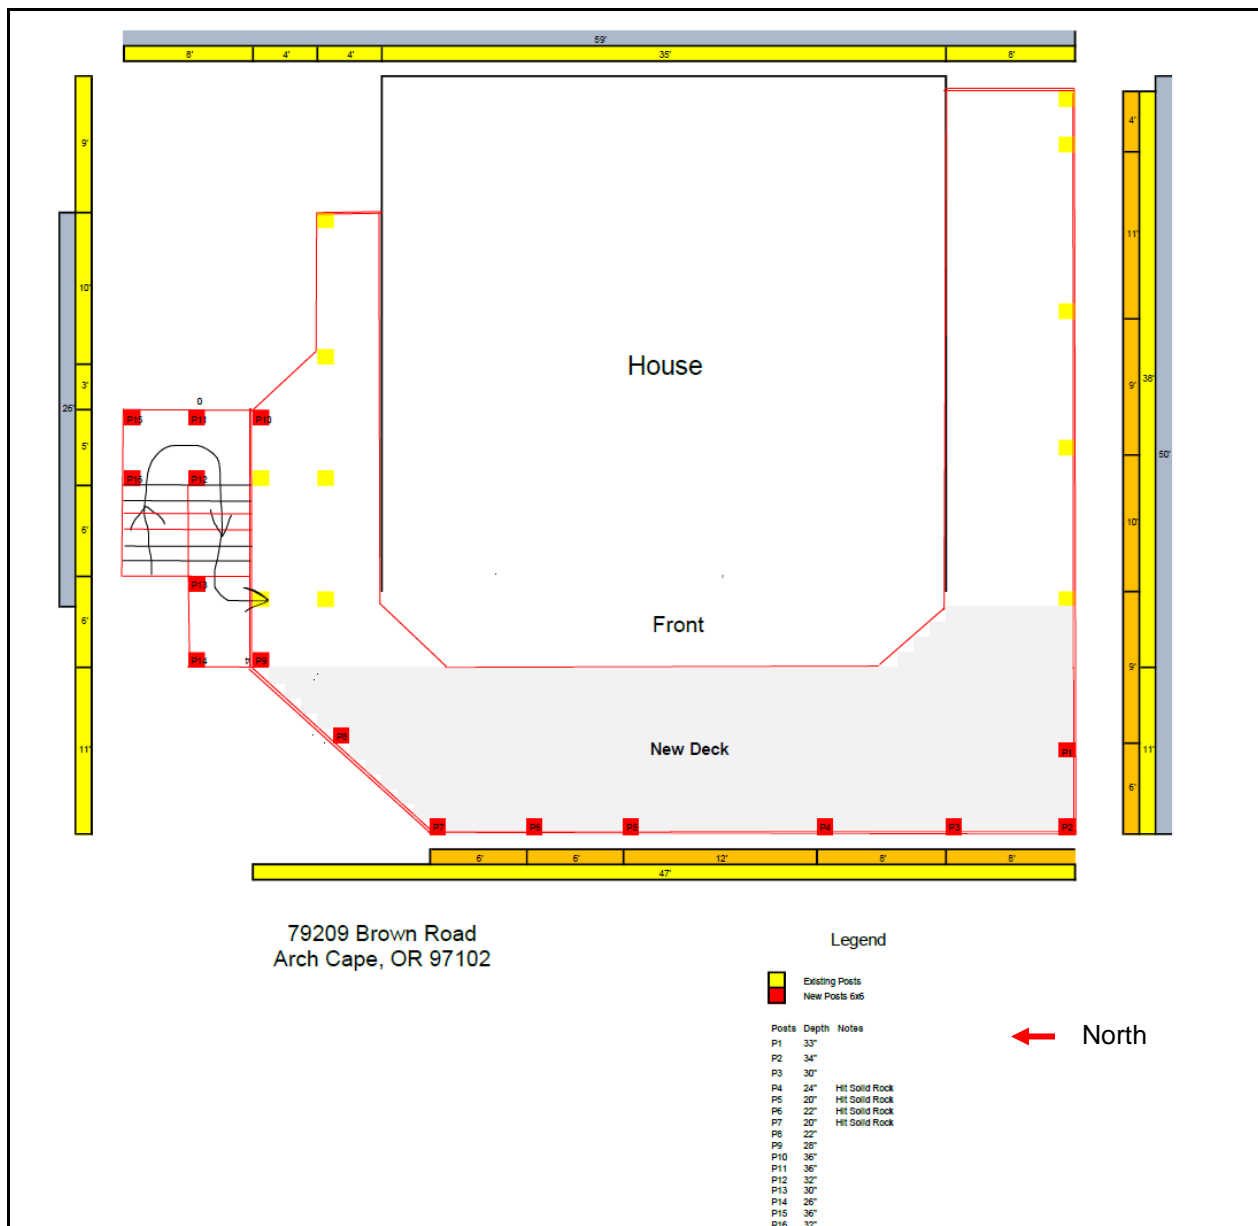
Figure 3 – Deck and Pier Plan provided by Tim Durham.

The proposed deck extension on the west side of the home will be supported on 16 newly installed concrete foundation piers in the near-level gravel driveway area, as shown in red pier positions in Figure 3. It is my understanding that a one-man, trailer-mounted power auger was used to advance the pier holes to as much as 36 inches below ground surface. Piers 4 through 7 on the west side of the home were reportedly advanced to refusal on solid bedrock at 20 inches to 24 inches below the gravel surfaced driveway grade. I do not expect additional excavation or earthwork to be conducted as part of this deck addition project. No new cuts or fills or significant landscape modifications are proposed. There are no reported issues with settlement or cracking of existing foundations at this residence. Similarly, there are no reported soil erosion, drainage, or slope stability concerns for the subject property.

The foundation pier drilling reported firm soil or bedrock at shallow depth. I would not suspect disturbed, organic, expansive, or highly compressible soil in the existing graded building pad. In my opinion design and construction of the proposed deck foundation piers in accordance with Oregon Structural Specialty Code (OSSC) is considered appropriate.

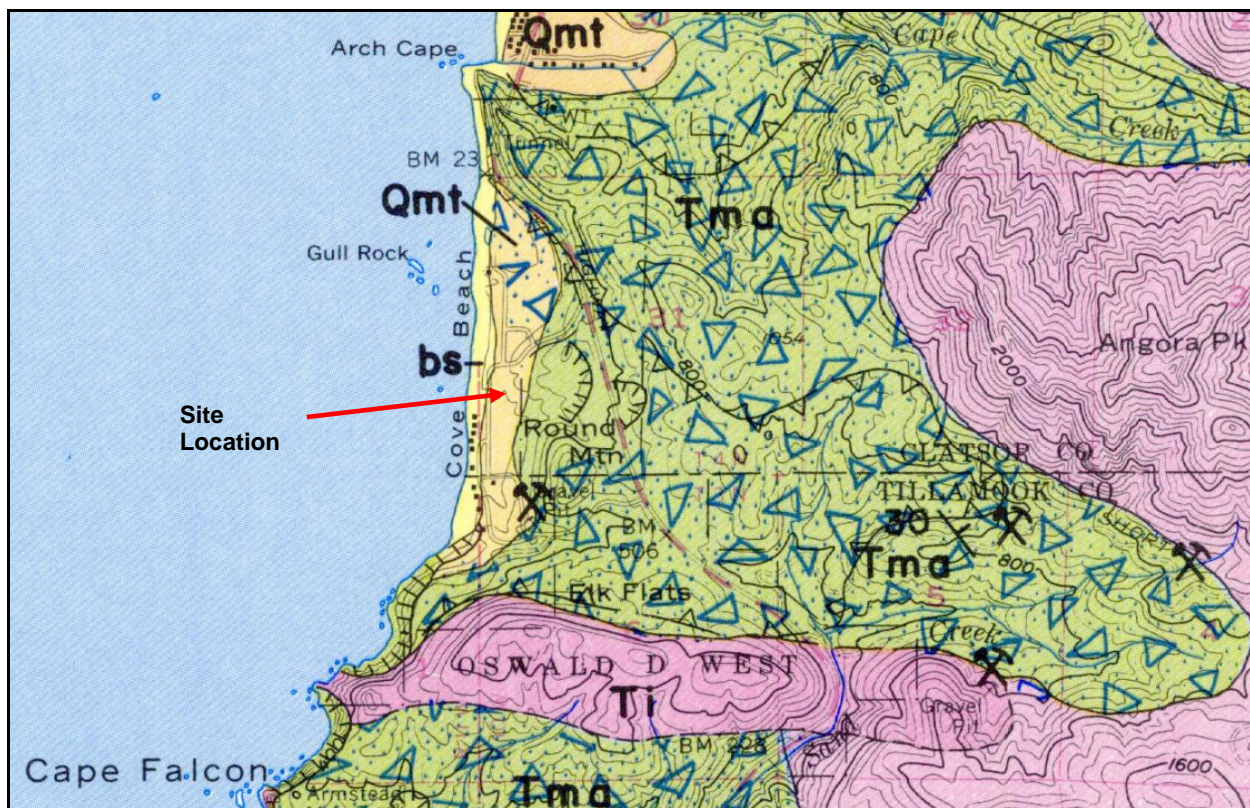
Figure 4- Portion of Geologic Map of Cannon Beach Quadrangle, DOGAMI Bulletin 74 (1972)

DOGAMI Bulletin 74 includes geologic mapping at a scale of 1:24,000 for the Cove Beach area. The southwest corner of the geologic map of the Cannon Beach Quadrangle is shown in Figure 4. Mapped geologic units of the project area include Quaternary marine terrace (**Qmt**) deposits of Pleistocene age (last approximately 1.8 million years). This marine terrace deposit is described as consolidated to moderately consolidated gravel, beach and dune sand that locally contains minor clay-rich paleosol, colluvium, debris flows, and alluvial interbeds.

Landslide disturbed, decomposed, Tertiary age, Oligocene to Miocene marine siltstone and sandstone bedrock of the Astoria Formation (**Tma**) lies upslope to the east of the subject property. DOGAMI maps abundant landslides in the Astoria Formation, both active and ancient, inactive landslide topography. The mapped active and inactive landslides are identified by black curved lines with barbs or tick marks. The ancient landslide topography of the Astoria Formation is mapped with a blue stippled and triangular shaped overprint pattern.

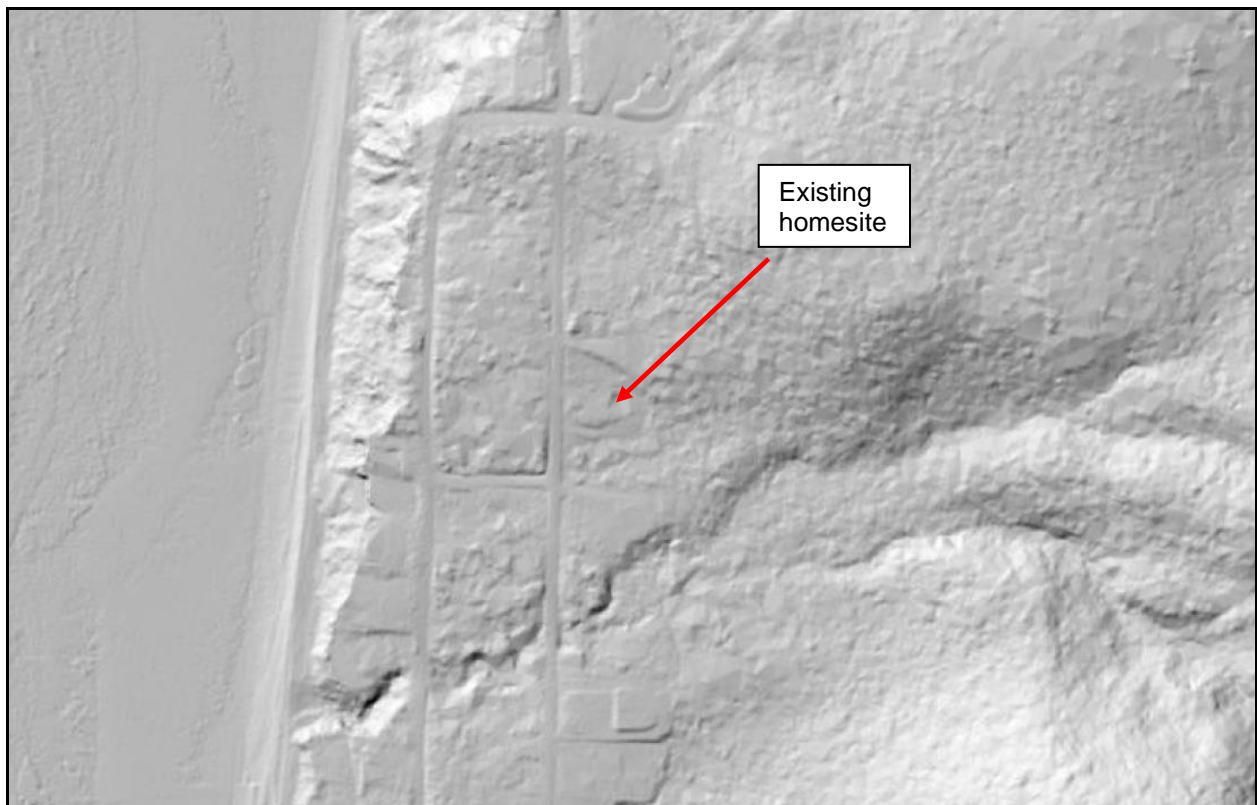
Figure 5- DOGAMI LIDAR viewer bare-earth shaded relief topographic image of project area.

Surveyed or detailed topographic mapping was not available for the property. To evaluate geologic landslide and slope stability conditions at a neighborhood scale, I reviewed available Light Detection and Ranging (Lidar) topographic land surface images on the DOGAMI LIDAR Viewer website. A shaded relief topographic image of the bare earth surface is shown for the project area in Figure 5. The Lidar image shows cut and fill roadway grading and natural topographic features like creek drainage and eroded bluffs of the active ocean shoreline to the west. I do not interpret active landslide, slope failure geomorphology, or landslide deposits at or near the subject property in the Lidar image.
