GEOLOGIC HAZARD PERMIT WAIVER

Permit #20190422

RE: **Geologic Hazard Waiver Letter**; Map 4 10 30BD, Tax Lot 3000; north side of Walsh Avenue,; SE part of Arch Cape, Clatsop County, Oregon

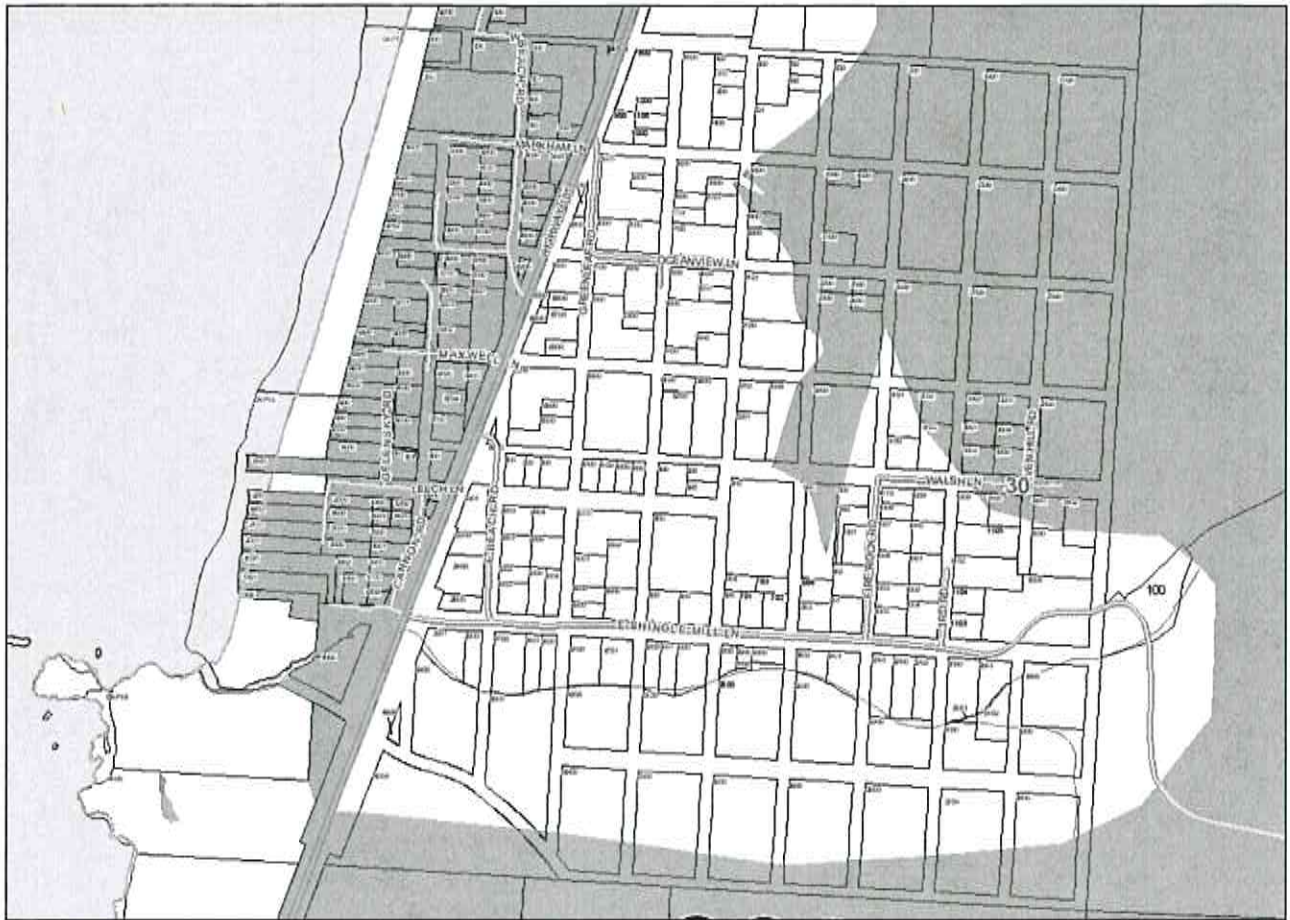
Figure 2: Geologic landslide hazard overlay (orange) for the southern part of Arch Cape. Tax Lot 3000 lies just within the area considered to be old landslide, on the northwest corner of the intersection of Walsh Lane and Raven Hill Road.

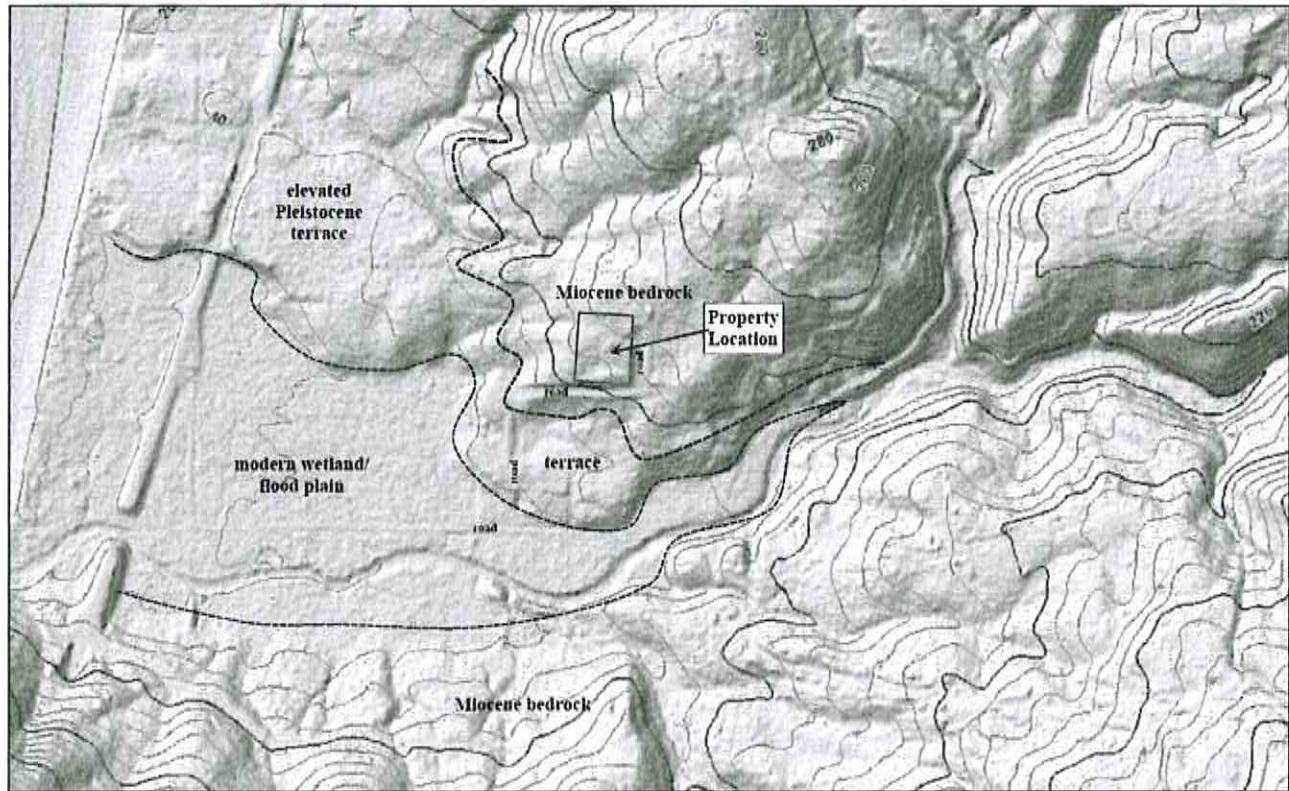
Figure 3: LIDAR shaded relief topographic map for the south end of Arch Cape, with geologic interpretations. Tax Lot 3000 is in the south-east corner of the blue rectangle and lies on Miocene bedrock, but above on-lapping terrace sediments. The topography reveals incised stream drainages in the bedrock and gentle undulating landforms that are typical of hills that are free of landslide movements. The local bedrock consists of peperite complex, or chaotically intermixed sandstone, siltstone, and volcanic breccias that were emplaced explosively on the sea floor as massive flows of Columbia River Basalt invaded the submarine delta of the Columbia River about 15.5 million years ago, according to Niem (personal communication). Erosional resistance of the basaltic breccias leads to the formation of spheroidally weathering outcrop, characterized by isolated boulders that can be as much as 20 ft across, scattered sparsely across the local landscape. Some of the larger boulders can be seen topographically as blocky ground in the LIDAR image. The blocky ground, however, is not equivalent to hummocky landslide landscape. Map from Horning (2013).

Based on geologic investigations on-site and regionally, plus the interpretation of LIDAR imagery for the area, it is my conclusion that this property does not lie within an area of past landslide activity. The geologic hazard overlay is in error for this site.

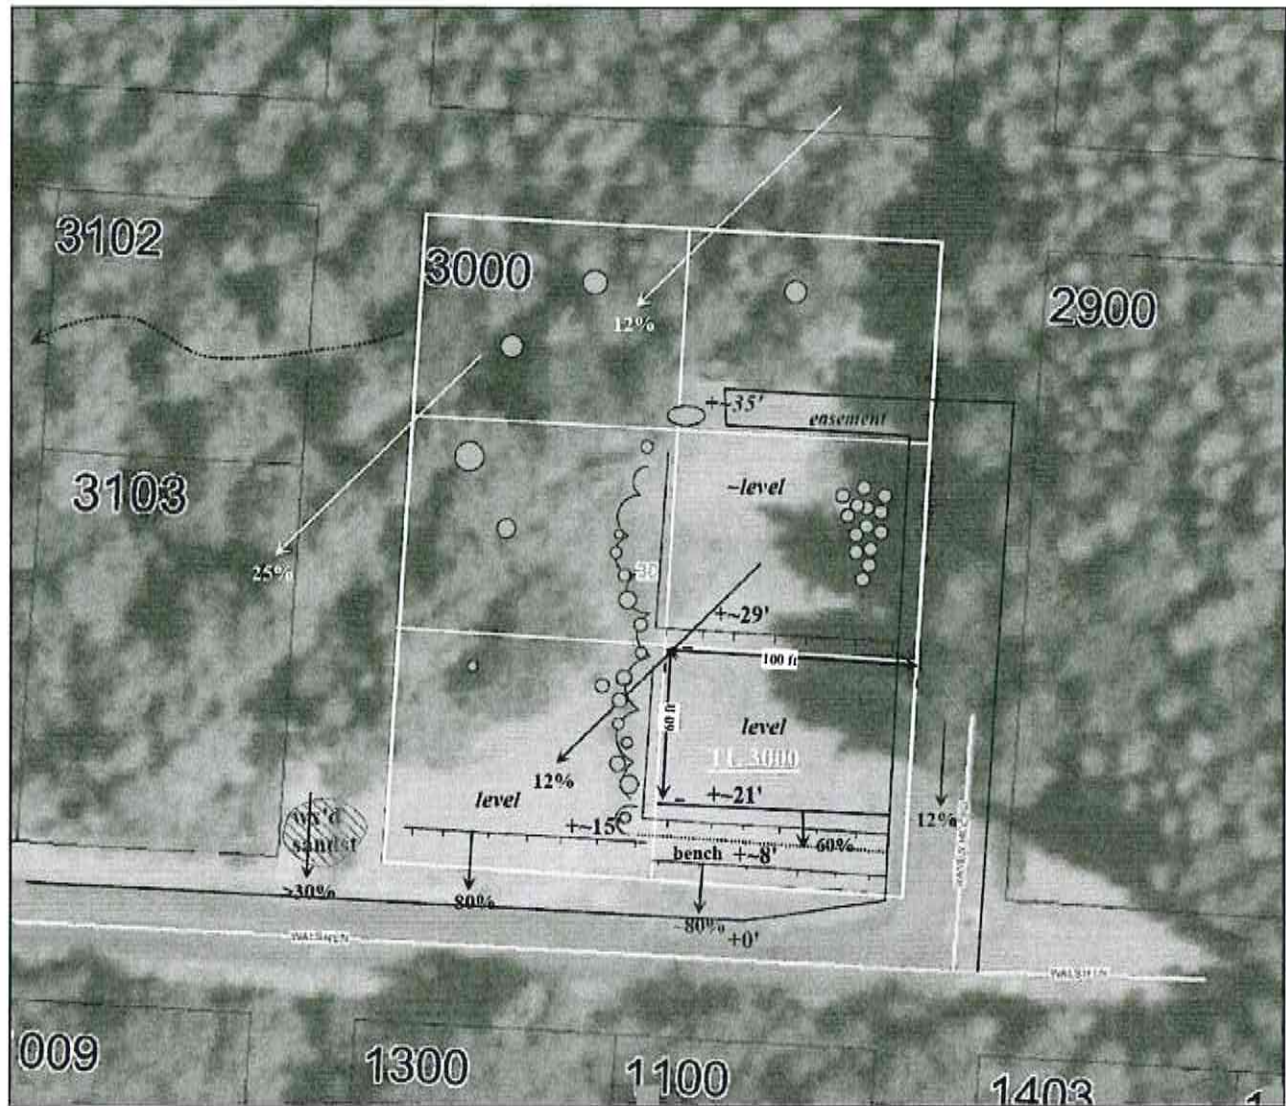
Figure 4: Site-specific observations for TL 3000 and nearby lots. Spheroidally weathered basaltic boulders are shown stacked west and north of the property. The proposed house should be constructed at least 10 ft back from the steep break-in-slope in the southern one-third of TL 3000, away from the embankment above Walsh Lane. The original slope for this property is estimated to have been about 12 percent to the southwest. The height of the leveled area is roughly 13 ft above the base of the upper cut bank, which is inclined from 50 to 80 percent. Given the presence of weathered sandstone exposed in Third Avenue in the partially excavated road cut west of the property, the cut bank can be expected to support a 1.5H:1.0V slope. It would be prudent to keep all foundations at least 10 ft back from the top of the cut. The bearing capacity of the gravelly clay-silt soils will be no less than 1500 psf. There may be hidden blocks of basaltic breccia buried beneath the surface of the lot, but it will disaggregate with a chisel-tipped rock breaker mounted on an excavator. Mapping after Horning (2013).

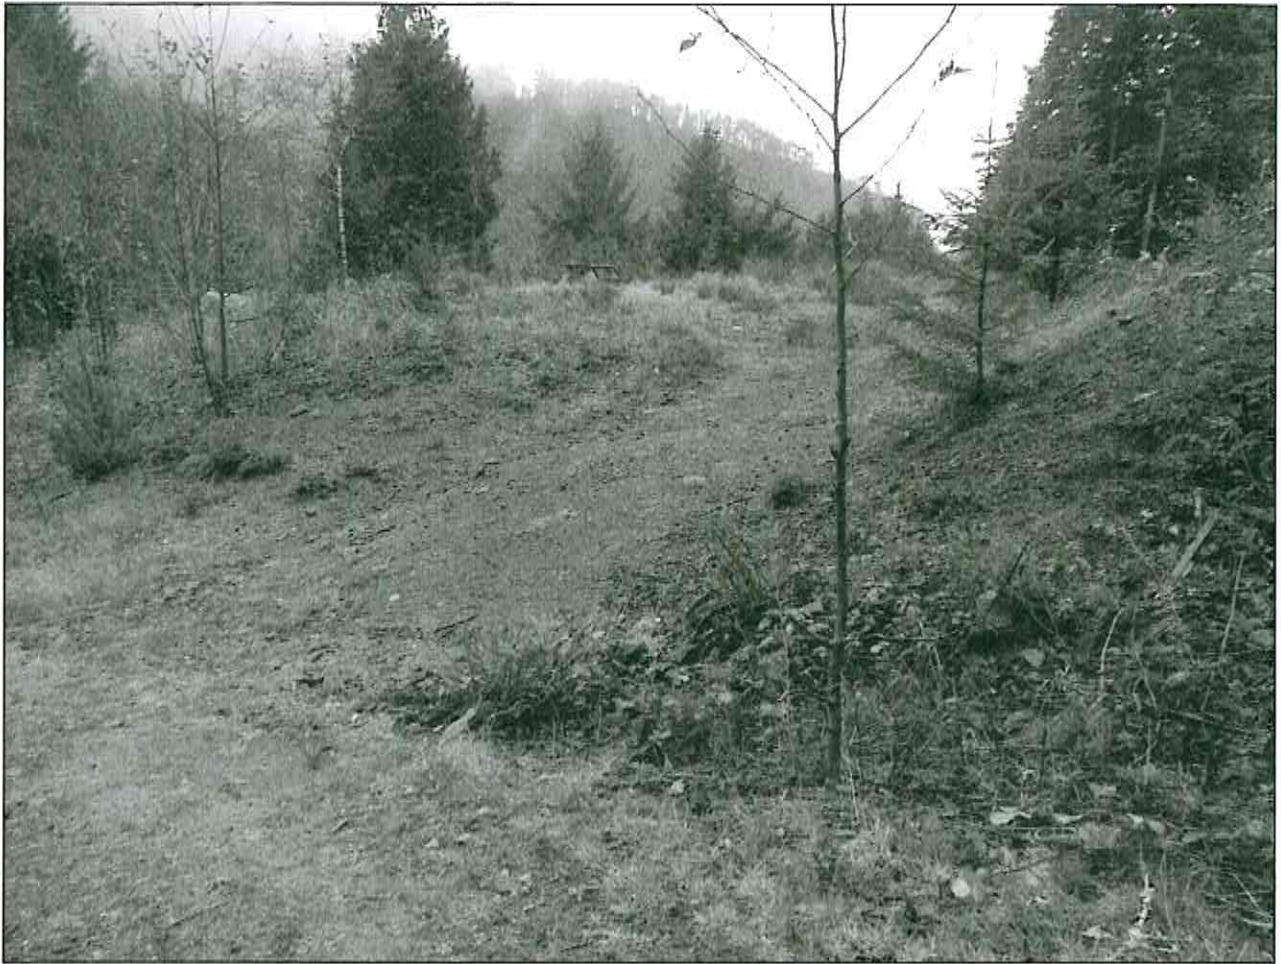
Figure 5: View of driveway ramp on east side of TL 3000, looking southwesterly. Blocks of basaltic rubble are up to 2 ft across in the exposed ground and may be larger in the shallow subsurface.
